Inspection Report Minerals Regulatory Program Report Date: October 14, 2004

Mine Name: Lisbon Valley

Operator or Permittee Name:
SUMMO USA

Permit number: M/037/088

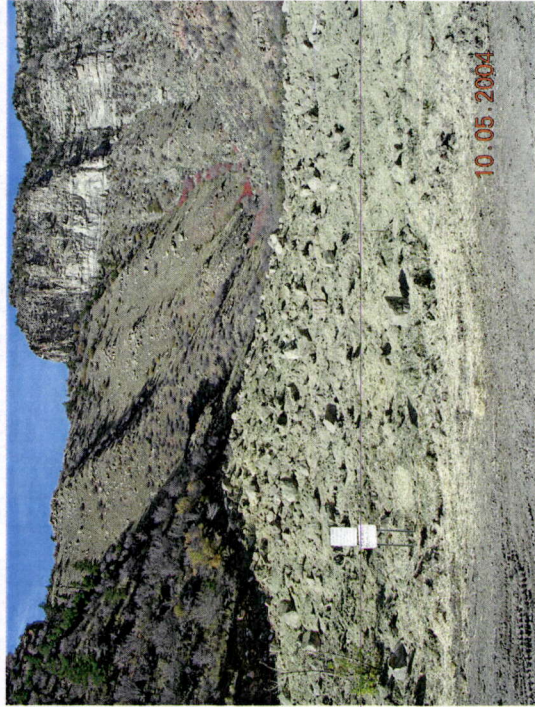
It is now late enough in the season that seeding could be done any time. It should not be delayed later than about December 1. Mr. Bauer and I discussed seedbed preparation methods. The surface should be left very rough, and seed should be spread as soon as possible after the surface has been prepared. Photo 1 shows the roughness at a site in Price Canyon. This type of surface preparation has been extremely successful.

Photo 1. Reclaimed area at the Willow Creek Mine in Price Canyon. Note the roughness and the amount of surface rock.

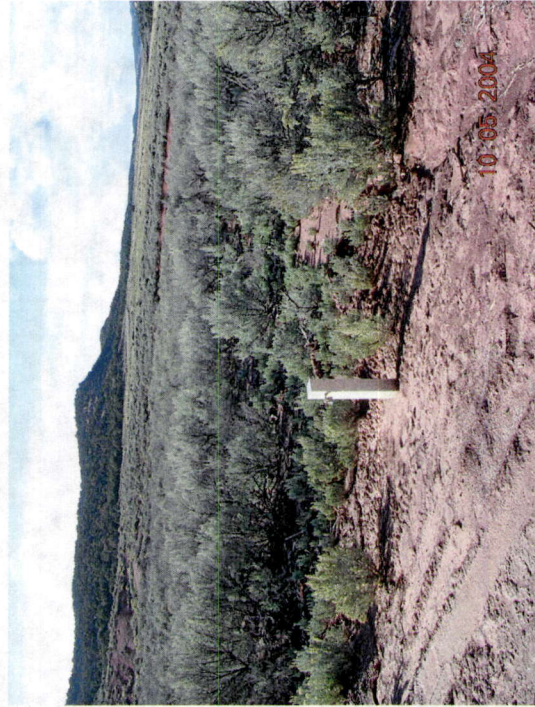
Wells PW3 and PW4 have been drilled recently, and according to Mr. Bauer, they are on sites C-5 and S-5 as proposed July 14, 2000. PW4 is not on the exact location of S-5, but Mr. Bauer said it was done this way to take advantage of disturbances already created by installation of the two piezometers 98R3 and 98R8. The piezometers and wells are shown in Photos 2-4.

Photo 2. Piezometer 98R3.

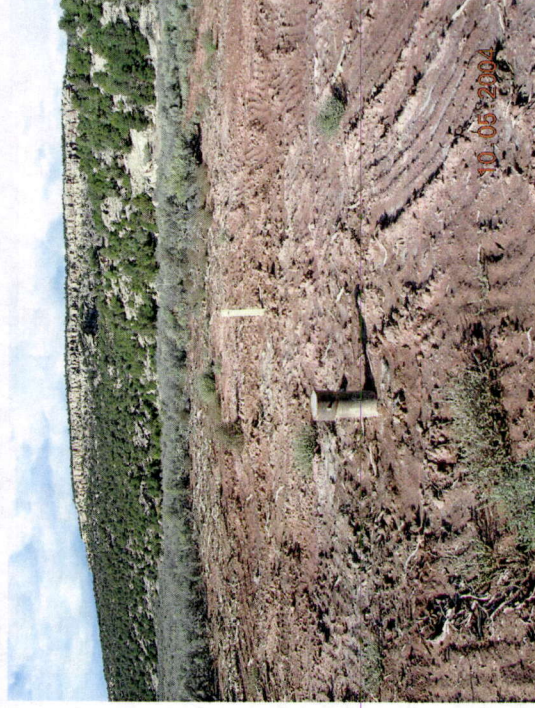
Photo 3. Well PW4 and piezometer 98R8.

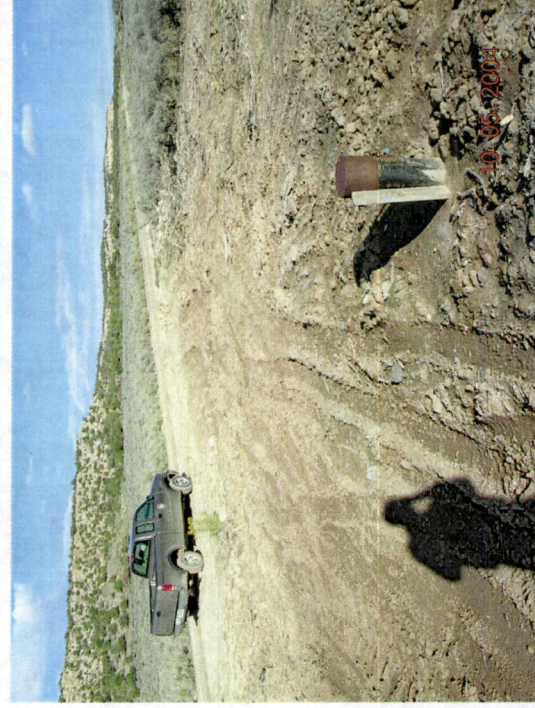
Photo 4. Well PW3 next to the Lisbon Valley Road.

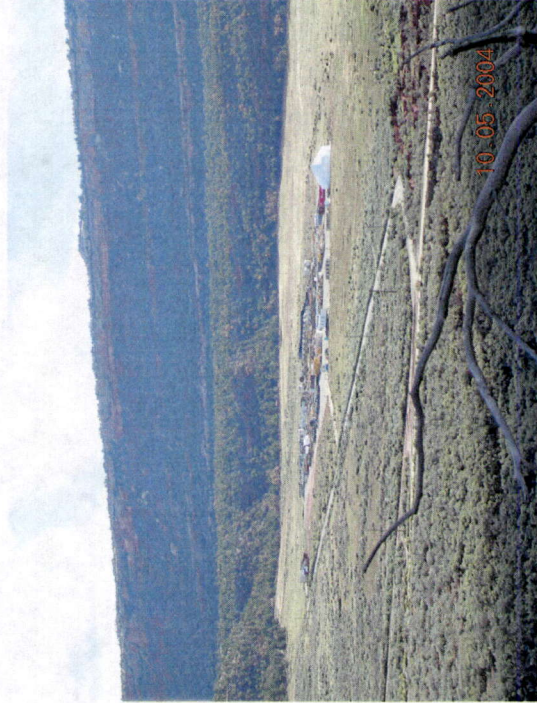
Since the last inspection, the operator has permitted an area for storing the crusher. This area is shown in Photo 5.

Photo 5. Crusher laydown area seen from the Sentinel Pit.
